THE DYER MONUMENT AND ITS PAINTED DECORATION

CONSERVATION OF THE MONUMENT

TOBIT CURTEIS ASSOCIATES

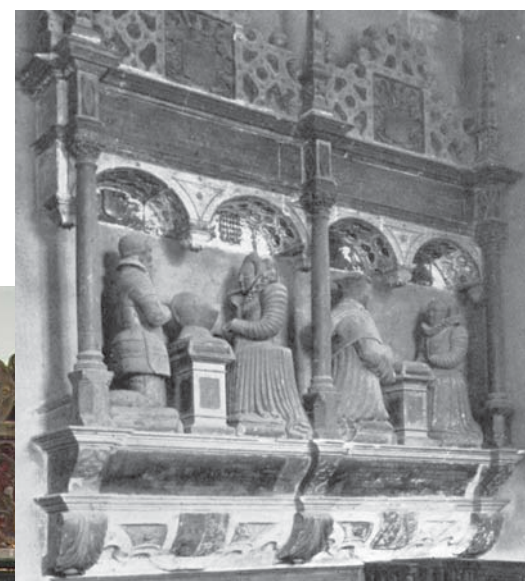
General view of the Dyer Monument prior to conservation. Note that although the helm between the figures on the left is original, that on the right and the adjacent gauntlets are not.

The deterioration of the monument, most evident in the damage to the ornately coffered arches and the lower section, was mainly caused by rainwater infiltration, from damage to the roof and gutters, which probably occurred prior to 1850. Repairs to the church in 1866 rectified the structural damage but also included re-rendering the interior walls with cement. The effect of the cement was to cause the moisture in the walls to evaporate through the more porous stonework of the monument, exacerbating the damage. Photographs taken throughout the 20th century demonstrate that by this period the deterioration had stabilised. By May 2002, when the conservation work was undertaken, the stone surface exposed by paint loss was powdering and the paint bordering these areas was flaking badly. A thick layer of dirt, as well as an historic restorer's varnish further obscured the surface.

The aim of the conservation treatment was to stabilise the damaged stonework and polychromy, and to reintegrate the paint losses, in order to reduce the visual disruption caused by the exposed white ground. Flaking paint was readhered using a weak acrylic dispersion and in areas where the exposed stone surface lacked cohesion, limited consolidation was undertaken with a very dilute acrylic resin. Surface cleaning was undertaken with crumbling conservation sponges and translucent watercolour washes were used to reintegrate the losses. The objective of the reintegration was not to recreate the original or disguise the losses but to reduce the visual impact of the exposed limestone. In conjunction with the work on the surface of the monument a number of minor structural repairs were also carried out. As a result of the conservation treatment, the structure and polychromy of the monument are now relatively stable. However, conservation is not a one off solution and the long term survival of this unusual and important monument depends on long term care and the continued good maintenance of the building. The conservation work was made possible by the generous financial assistance of the Council for the Care of Churches.

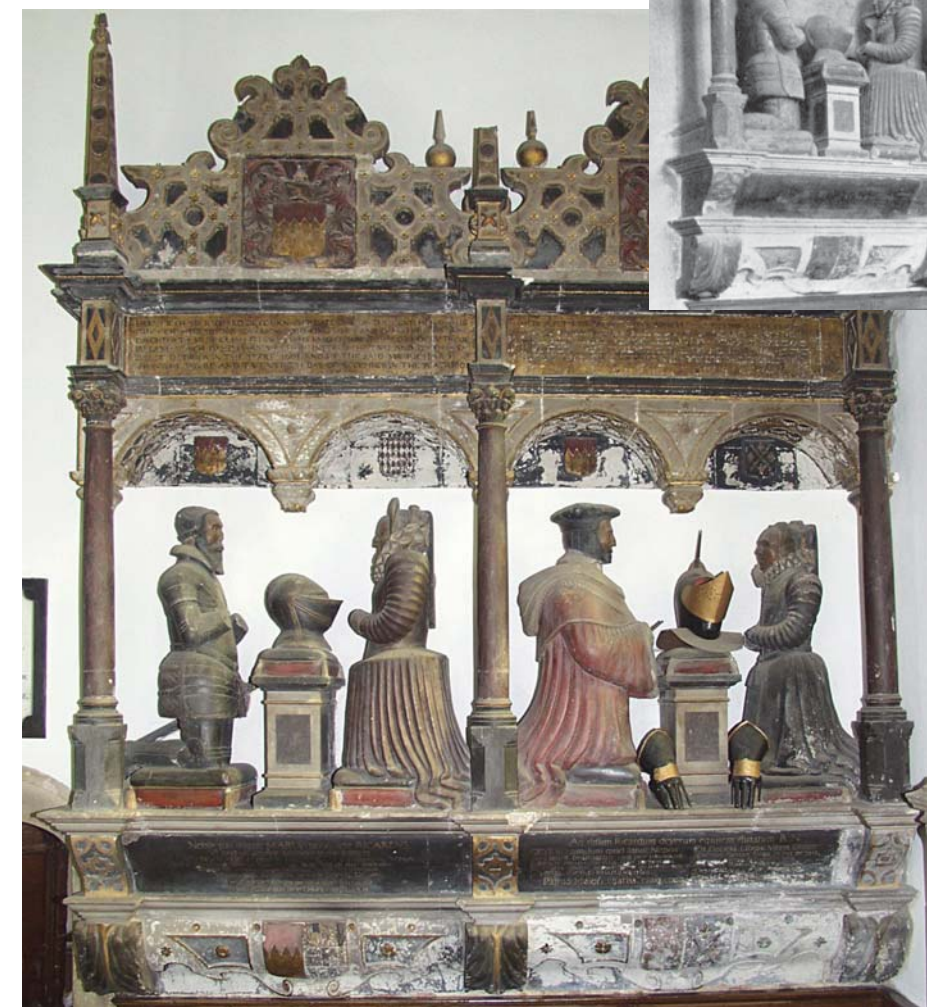
The earliest known photographic record of the monument c.1926, shows that the significant losses are historic. Later photographs confirm that the deterioration did not continue to a great extent after this date. The wall must have dried out, and the deterioration stabilised prior to this date.

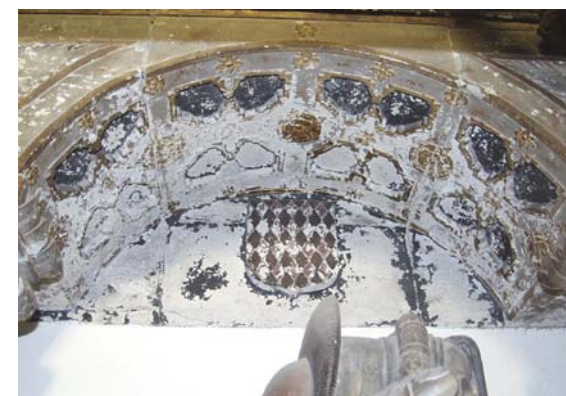
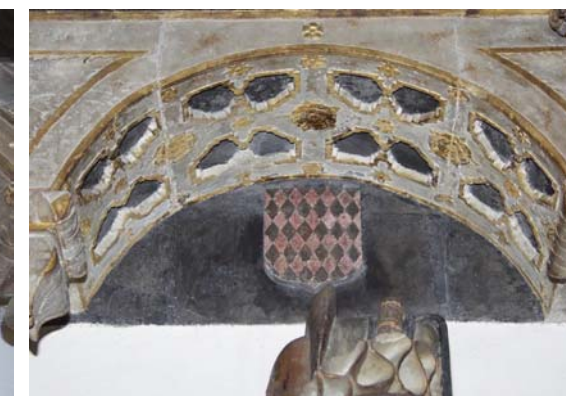
Detail of the soffit above Lady Margaret Dyer, before conservation and after conservation.
