## CURRENT APPROACHES TO THE CONSERVATION OF ENGLISH WALL PAINTINGS SUFFERING FROM HISTORIC WAX TREATMENTS.

### Tobit Curteis

A project of this type was recently undertaken on the 14<sup>th</sup> century wall paintings in the north transept of St George's Church, Kelmscott, approximately 20km south west of Oxford. The paintings, which were first uncovered in the late 19<sup>th</sup> century, had been treated with a wax based consolidant in the 1930s. By the 1970s, the coating had darkened significantly, and flaking of the paint and plaster layers was observed in certain areas. Some areas of the paintings were treated at this time and the wax partially removed, but large areas were left untreated and the deterioration continued.

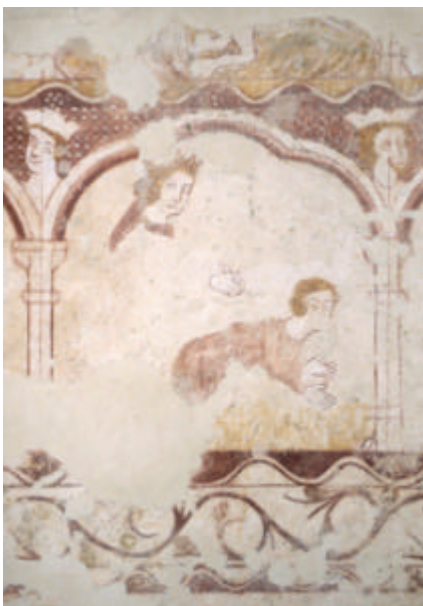
Figure 2. Detail of the painting on the west wall.  
(Photo: Tobit Curteis Associates 2000)

The first stage of the project was to carry out a thorough technical examination of the paintings, looking at their present condition, the rate of deterioration and the level to which the wax had penetrated the paint layer. Although the deterioration was serious in some areas, it was found that the penetration of the wax layer was relatively limited and, in general, the pigment and the wax were not intermingled.

The treatment of the paintings was carried out following the stabilisation of the internal environmental conditions. Due to the level of delamination between the paint and ground layers and, in some cases, between the plaster and the wall structure, it was in fact necessary to reduce the wax layer, to allow these areas to be treated. Following extensive testing, this was achieved using a xylene and white spirit mixture applied in a pappina (beeswax and water emulsion) support. It was accepted from the outset that although the wax had not penetrated deeply into the paint layer, the removal of the visible wax

would not significantly increase the porosity of the paint layer. Readhesion of the paint layer was undertaken using a weak solution of Plextol B500 applied through a Japanese tissue intervention layer and the plaster and wall structure was treated using lime putty based plasters and grouts.

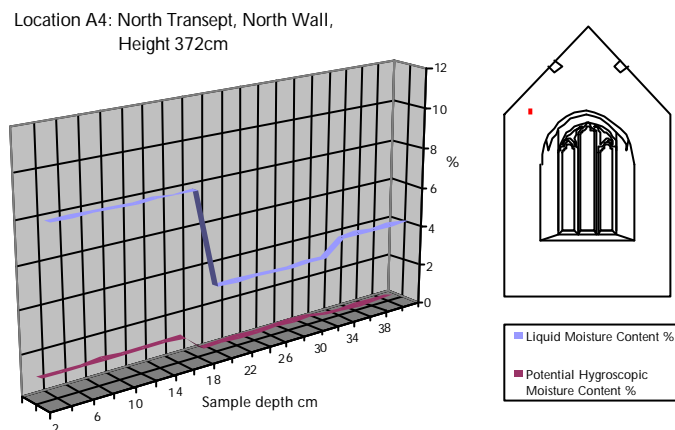
**Figure 3.** Moisture content of the core sample from the upper part of the north wall.

The results of the liquid moisture survey showed that although there had been significant problems with capillary rise of ground water in the past, the current drainage system had reduced the height of the capillary rise to below the level of the surviving wall paintings. It was found that deterioration to the top of the paintings was still occurring due to damage at the junction between the roof and the gable wall. However, this was relatively easy to control by carrying out repairs to this part of the roof.

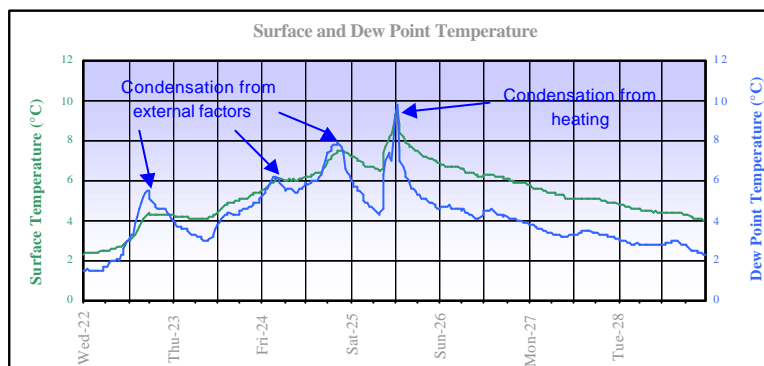
Of more concern were the results of the monitoring programme. This showed that while the church was well buffered and in general the internal microclimate was relatively stable, both the heating system and the high ventilation levels caused significant and damaging fluctuations in the conditions which regularly led to the formation of both superficial and interstitial condensation. This level of fluctuation in the internal relative and absolute humidities as well as the regular condensation, would inevitably increase the level of salt activity, accelerating the deterioration in both the paint and plaster layer.

**Figure 4.** graphs showing the periods in December 1999 when the dew point temperature rose above the surface temperature as a result of ventilation and heating.

Therefore, recommendations were made for the reduction in the level of deliberate ventilation and significant changes to the heating system (which at that time included portable gas heaters). The environmental conditions were then monitored for a further twelve months and the results demonstrated that the conditions, although by no means perfect, had improved noticeably.

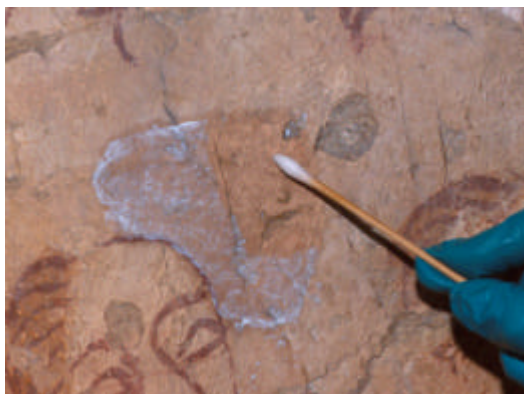
**Figure 5.** Reduction of the wax layer using solvents supported in pappina. (Photo: Tobit Curteis Associates 2000)
