# THE CONSERVATION OF THE WALL PAINTINGS AT ILKETSHALL ST ANDREW PARISH CHURCH

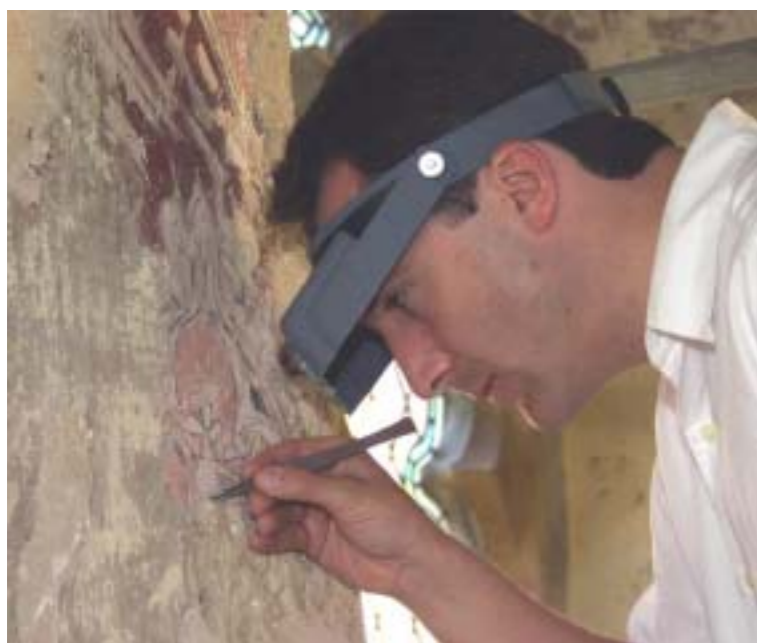
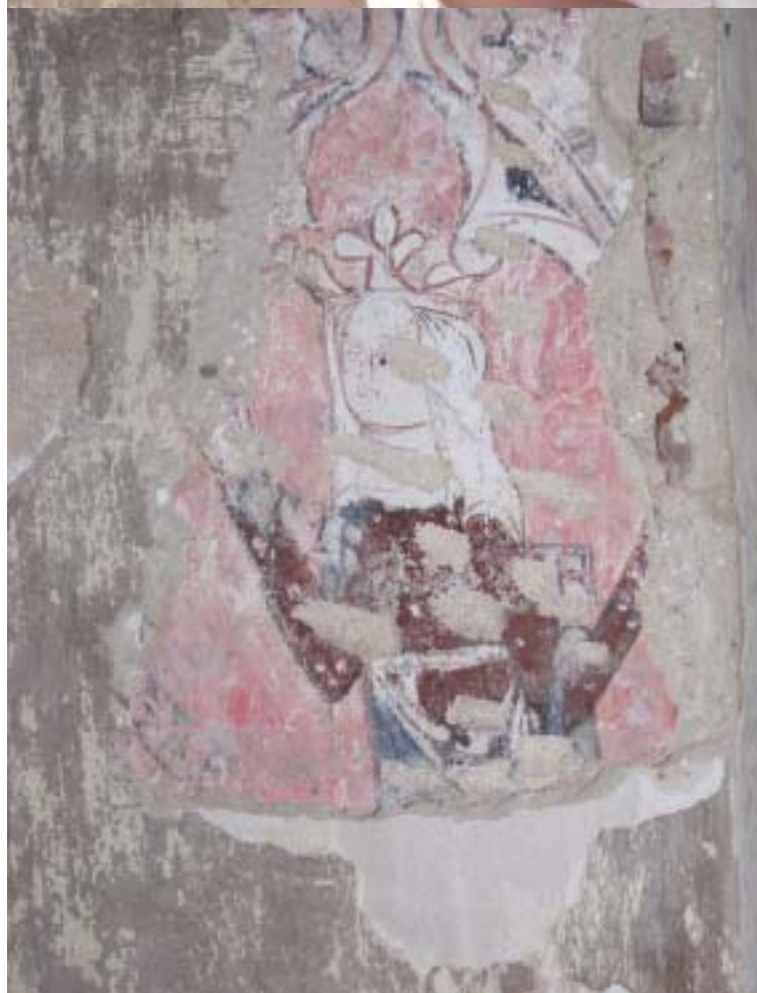
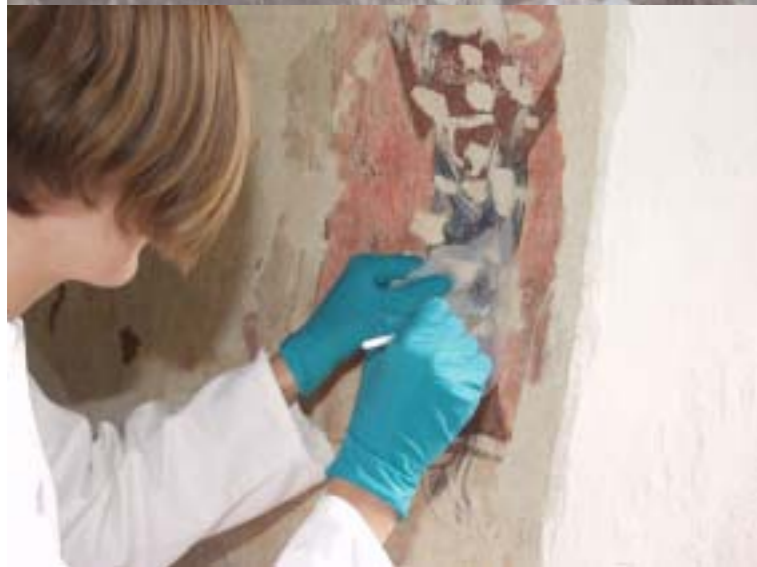
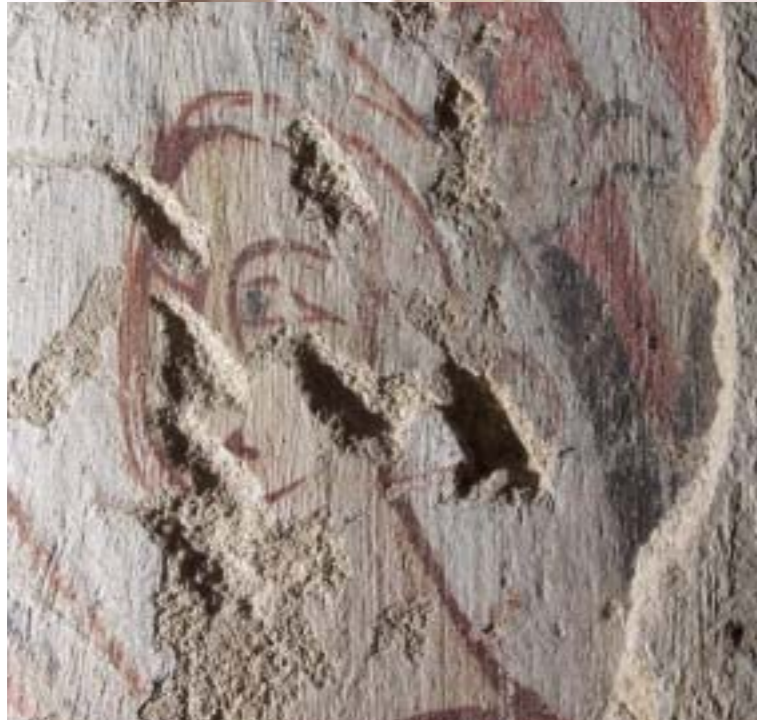
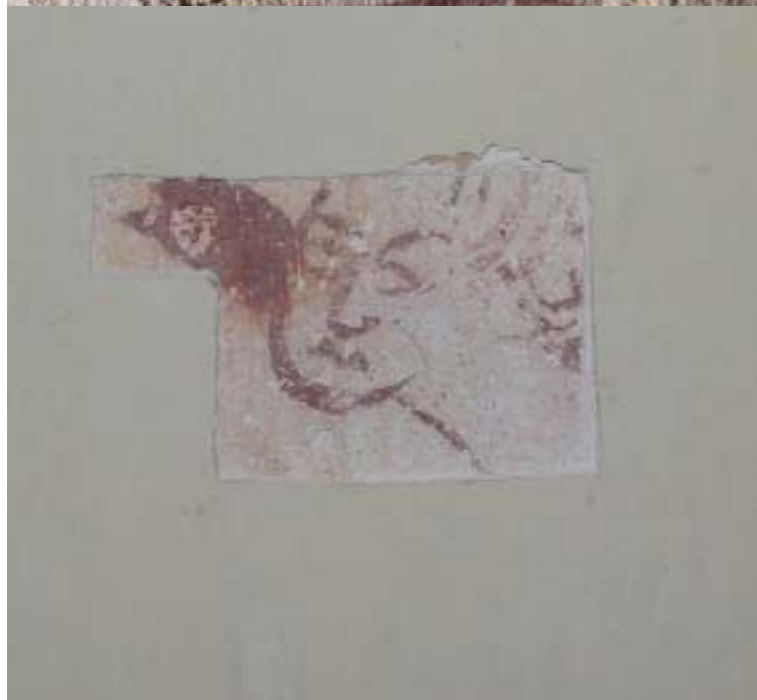
Conservation work in progress

The treatment involved the slow and painstaking removal of layers of limewash from the original paintings using tiny scalpels and dental tools. Once revealed, the paint layer was stabilized using methods which do not preclude other conservation techniques should further treatment become necessary in the future. The level of reintegration was limited, involving the use of toned limewash and watercolour washes on the losses, but the effect was to enable the surviving paint layer to become readable rather than being obscured by the areas of damage.
