# THE UNCOVERING AND CONSERVATION OF THE MEDIEVAL WALL PAINTINGS AT ST JAMES THE LESS' CHURCH, LITTLE TEY

by Tobit Curteis

Published in 'The Uncovering And Conservation Of The Medieval Wall Paintings At St James The Less' Church, Little Tey', *Essex Archaeology and History*, Vol 29, 1998, pp.136-144

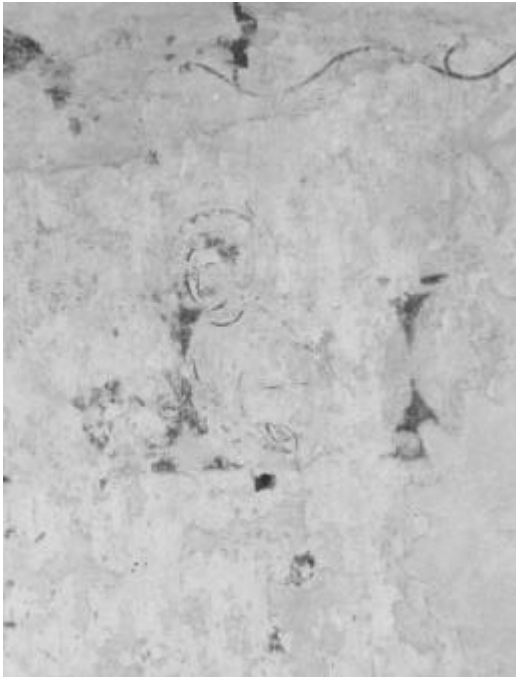
**Plate 1.** The Christ Child on the shoulder of St Christopher, on the north wall of the nave. (Photo copyright: Tobit Curteis Associates)

visible. The Christ Child sits on the shoulder of the saint, with an orb in his left hand and his right hand raised in a blessing.

Interestingly, he appears to have a scalloped rather than a crossed halo. [Plate 1] The figure of St Christopher is extremely fragmentary with only a section of the head and bearded face readily visible, though fragments of his dark drapery can be seen on the plaster below. Paint analysis demonstrated that the black pigment was a converted lead pigment. Above and to the right of the figures is a border of contemporary vine scroll, painted partly on a fine lime mortar repair with which it appears to be contemporary.

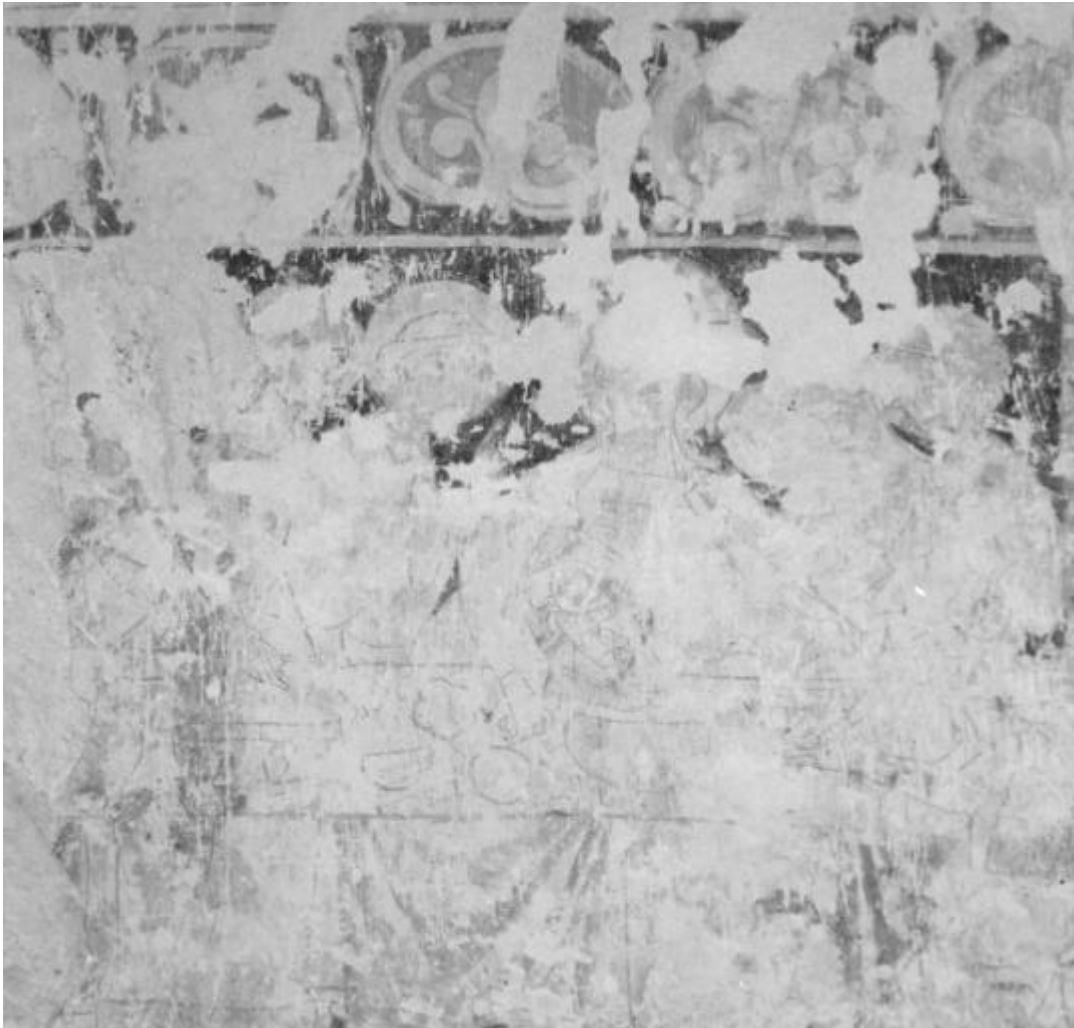
**Plate 2.** The central section of the Last Supper on the north wall of the apse. (Photo copyright: Tobit Curteis Associates)

The iconography of both scenes is not unusual for the period. In the Last Supper, Christ sits at the centre of the table with St John asleep on his breast and the other

disciples on either side. [Plate 2] His left hand is held out to Judas who kneels on the other side of the table with his head bent back and his arms outstretched. In the Washing of the Feet, Christ is seen kneeling before St Peter, holding his foot above a raised water basin, and with his left hand raised to admonish Peter for his reticence. Peter has his left arm upraised in surprise, while the rest of the apostles look on. An almost identical representation occurs in a manuscript of c.1220-30, at Emmanuel College, Cambridge (MS25, folio II).<sup>vi</sup> Interestingly, in the manuscript, Christ has the towel over his shoulder in the more conventional manner, while in the wall painting, the towel is hung over a rail at the back of the scene.

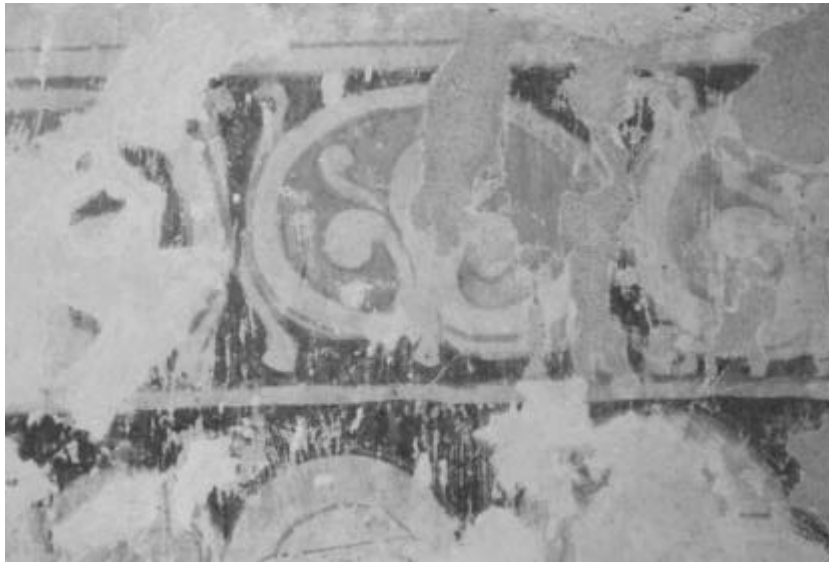
**Plate 3.** of the decorative border above the Last Supper.  
(Photo copyright: Tobit Curteis Associates)

The trefoil devices in the upper border, [Plate 3] which is particularly clear in this area, is very similar to that found on the nativity cycle at St Clement's, Ashampstead, in Berkshire, which has been dated to the early to mid 13<sup>th</sup>-century.<sup>vii</sup> Such an early date for a Passion cycle, makes the scheme of paintings at Little Tey a particularly rare example.

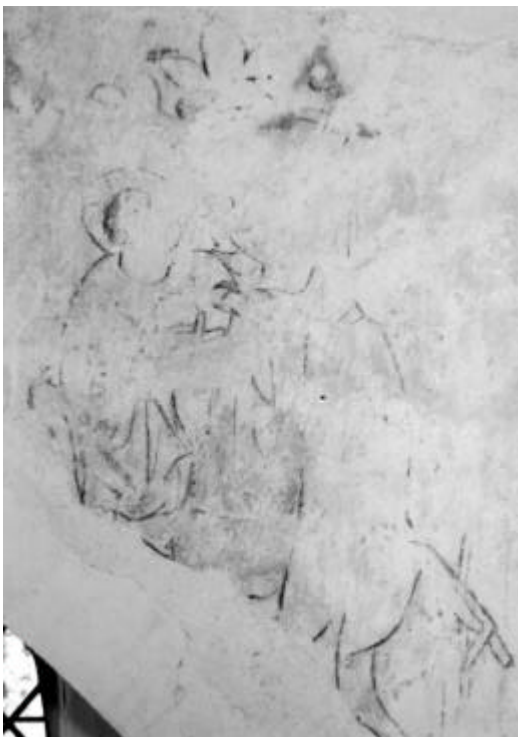
**Plate 4.** The Virgin and Child on the south wall of the nave. (Photo copyright: Tobit Curteis Associates)

**South Wall (Areas 7 to 9)** Immediately to the right of the window is a very fine depiction of the Virgin and Child, with the Child, who is holding a orb, sitting on the hip of the crowned Virgin. [Plate 4] The Virgin can be seen to be holding the stem of a lily in her very delicately painted left hand. A rather similar but more sophisticated depiction of c.1300 can be seen at Little Wenham Church, in Suffolk. [Plate 5] As with the Three Living and the Three Dead, with which it is contemporary, the scene has been cut into by the insertion of a later window.

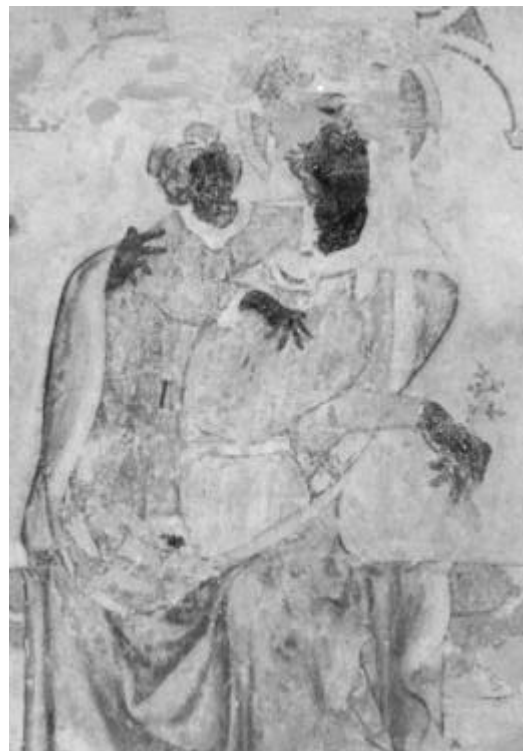
**Plate 5.** The Virgin and Child at Little Wenham. (For comparative purposes, this plate has been printed in reverse). (Photo copyright: Courtauld Institute of Art)

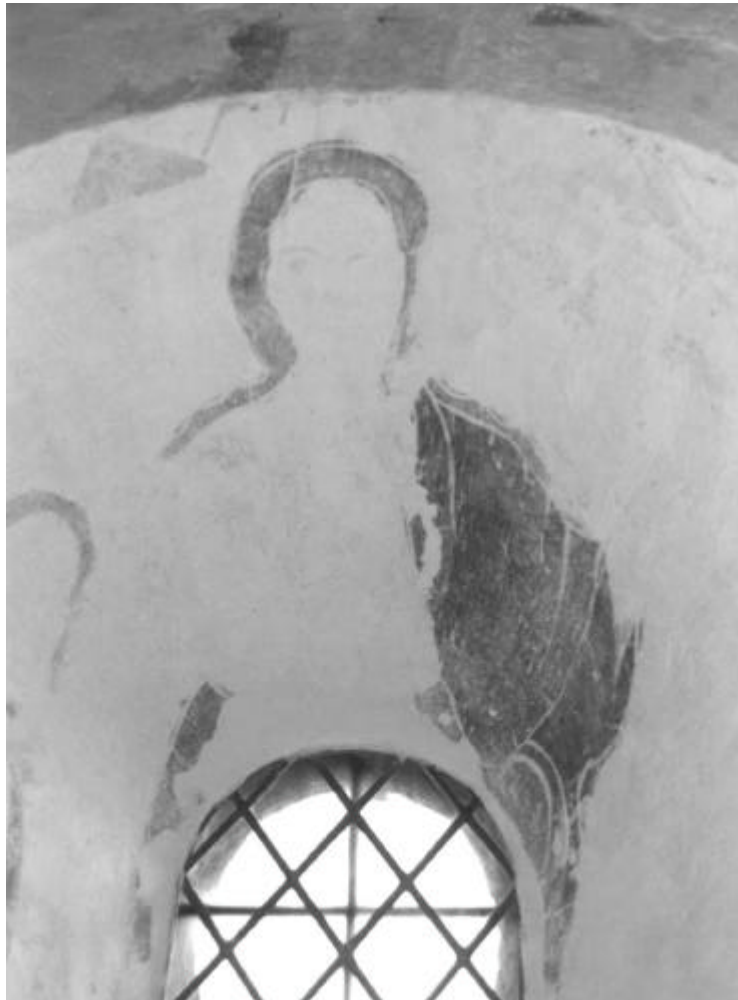
**Plate 6.** The figure in the soffit of the window in the south wall. (Photo copyright: Tobit Curteis Associates)

The 13<sup>th</sup>-century figure in the soffit of the window between areas 7 & 8 wears a white undershirt with a red cloak over its left shoulder. [Plate 6] While most of the facial and other linear details, including the halo, have been lost, the figure retains most of its bright yellow hair. Due to the lack of detail, the identification of the figure is not clear. However, it is possible that it is one of a series of paintings of saints or martyrs which would originally have adorned all of the 12<sup>th</sup>-century windows.<sup>xi</sup> On the eastern splay of the window is a second similarly dressed figure also with yellow hair. However this figure, who holds what appears to be a scroll in its left hand, is wearing a red robe over its right shoulder. The outside edge of the window is decorated with a chevron pattern painted in light pink, which has deteriorated significantly. Although the details of the figure differ, this same form of painted decoration on the soffit and splays of windows is seen at Easthorpe Church in Essex and at Barfreton Church in Kent.
