# THE CONSERVATION OF THE WALL PAINTINGS AT ST MARY AND ALL SAINTS' CHURCH, WILLINGHAM

## CONSERVATION

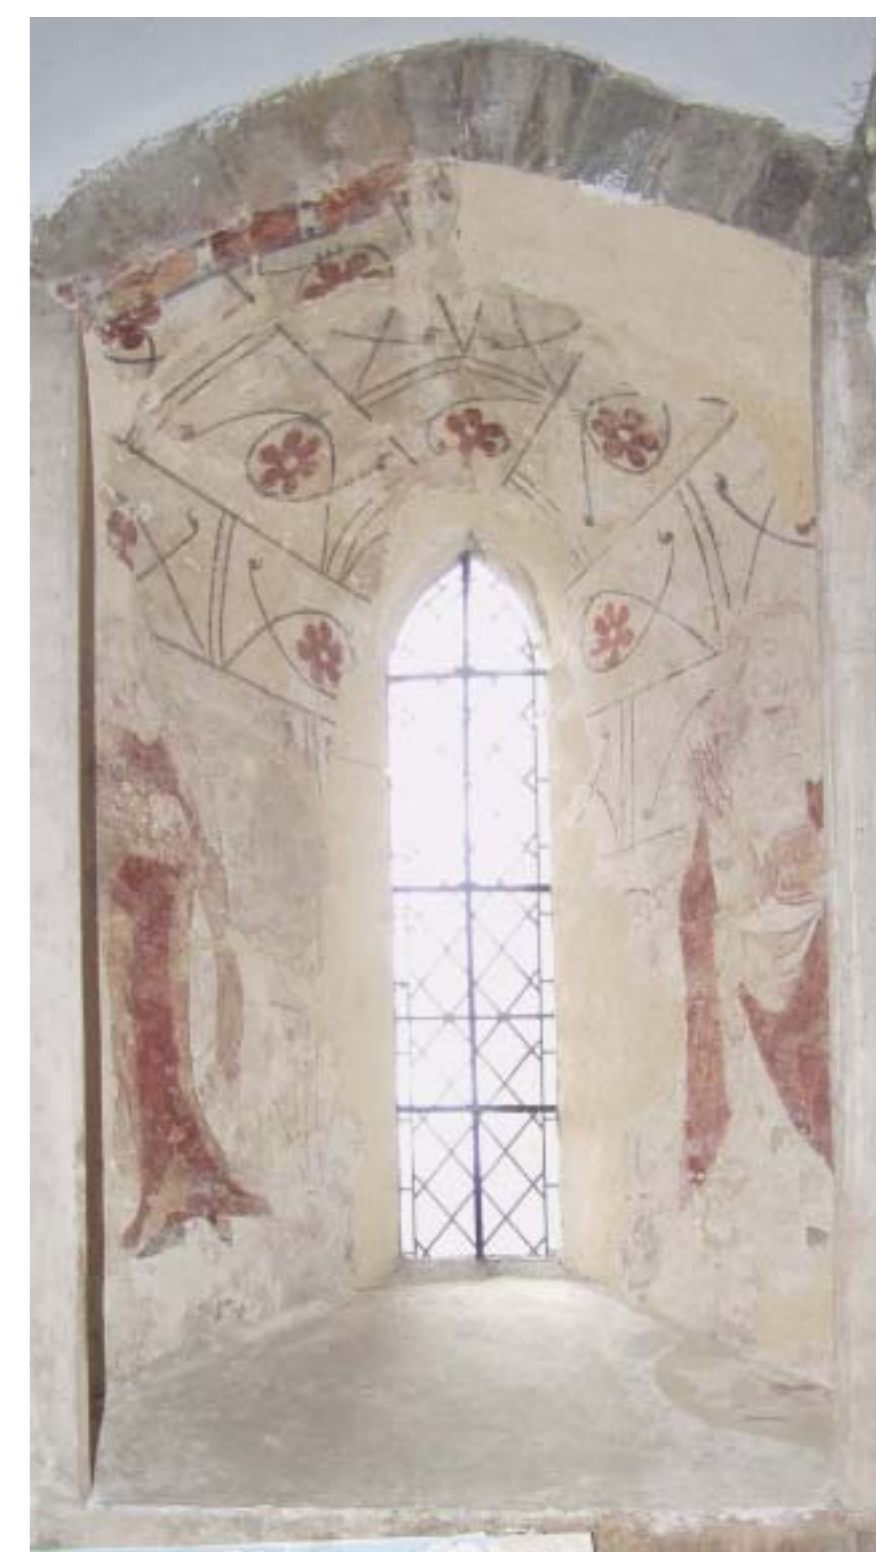
The earliest wall paintings which are located in the small 13<sup>th</sup> century window on the west wall of the south aisle, consist of two schemes, the earlier of which is the double line masonry pattern, decorated with ornate floral motifs, and painted quoins. On a limewash layer above this are two elegant female figures, possibly showing St Etheldreda, the founder and abbess of Ely (d.679) and her sister, St Sexburga (d.c.699). While the figures are obviously later than the masonry pattern, it appears likely that both layers of painting date to the mid to late 13<sup>th</sup> century.

*The 13<sup>th</sup> Century paintings in the south aisle*

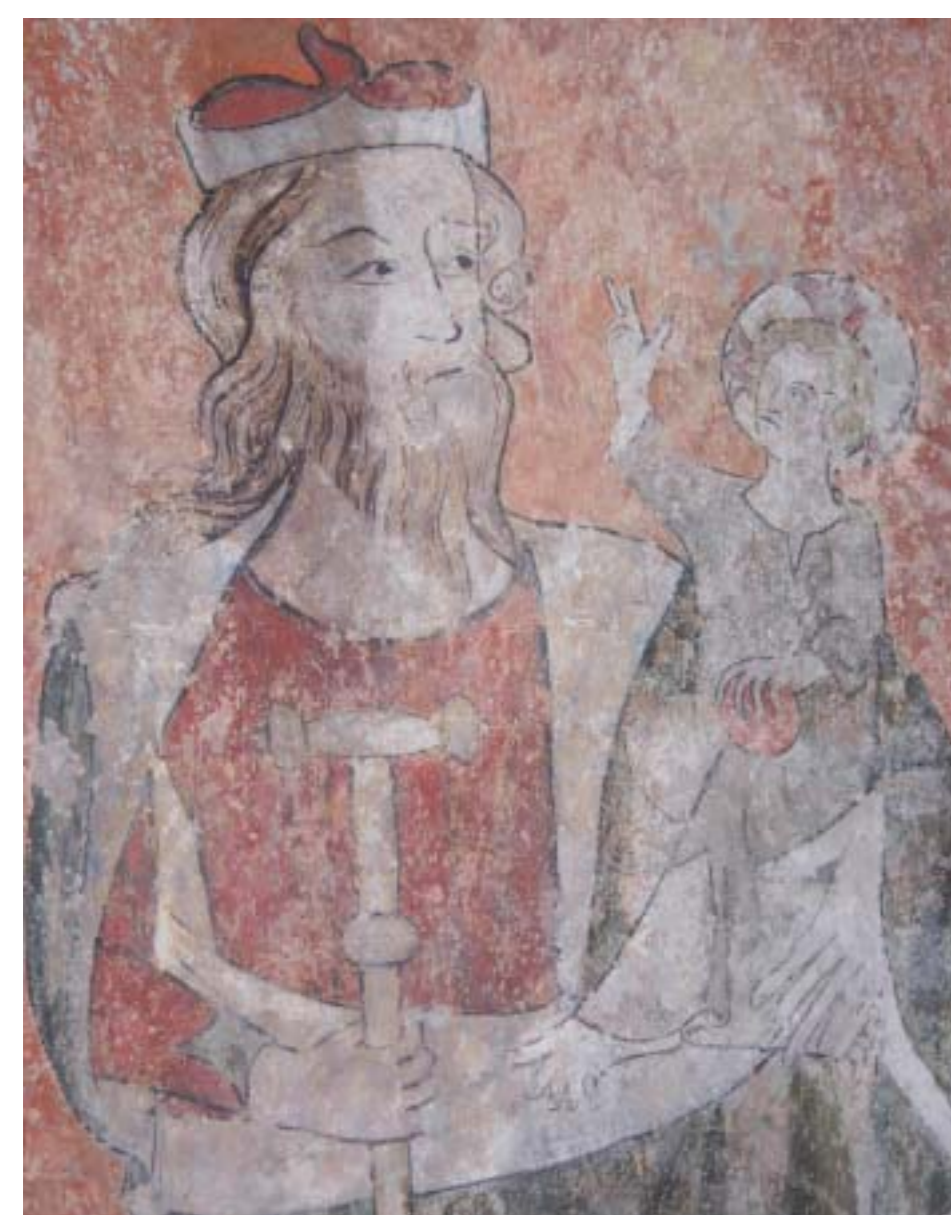
*Detail of the 14th century St Christopher*

The next paintings, in chronological order, appear to be the scenes of St Christopher and St George, on the north arcade, which are thought to date to the mid 14<sup>th</sup> century. The scene of St Christopher is unusually complete, with the figure of the saint in red and green robes, holding a Tau crossed staff in his right hand, and the Christ child on his left arm.

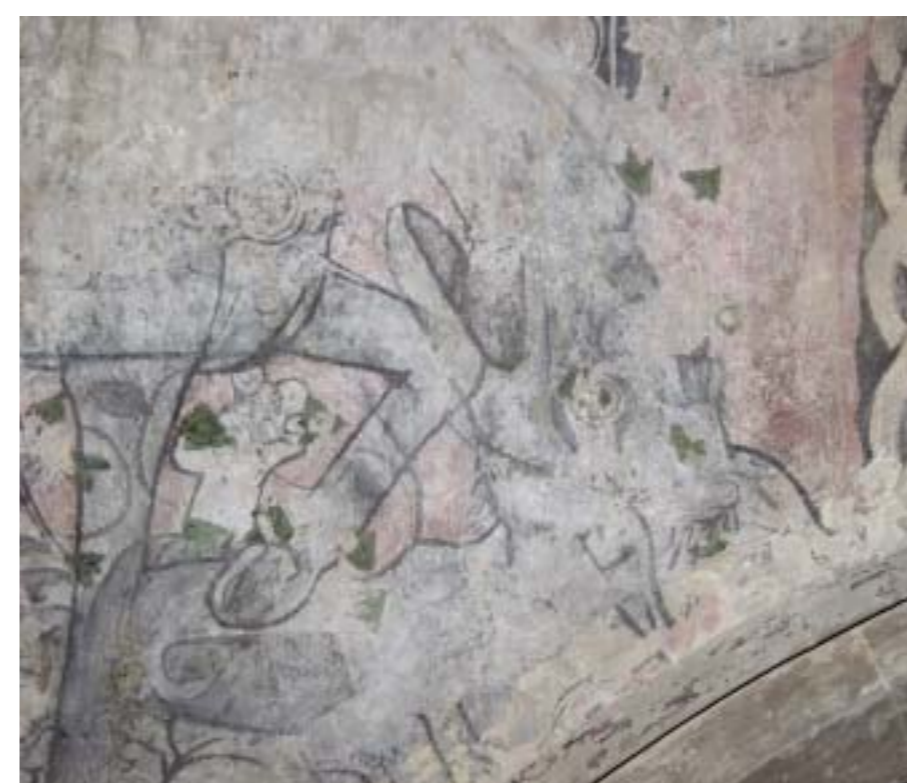
*Digital reconstruction of the head of the Dragon, based on the Konopiste sculpture*

In the middle of the nave north wall is the badly damaged scene of St George and the Dragon in a bold cable moulded frame. Clearly visible in the lower part of the painting are St George's horse, the broken lance and the coils of the dragon, with blood flowing from his side, while in the top left corner are the remains of the walled city with the crowned king and queen watching the contest. The figure of St George and the central section of the painting are almost completely lost, but the point of his raised sword can be seen above the frame. It has been suggested that the paintings of St Christopher and St George are of a similar date. However, stylistically they are rather different and it is interesting to observe the iconographic similarities with a relief sculpture of St George and the Dragon of c.1500 from Konopiste Castle in the Czech Republic.

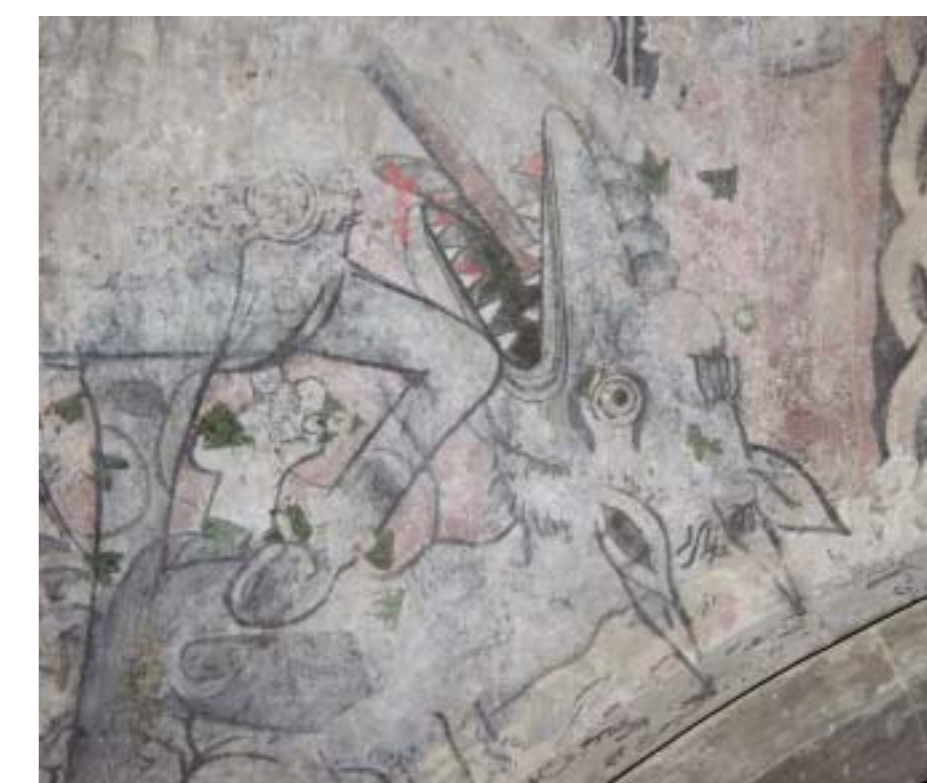
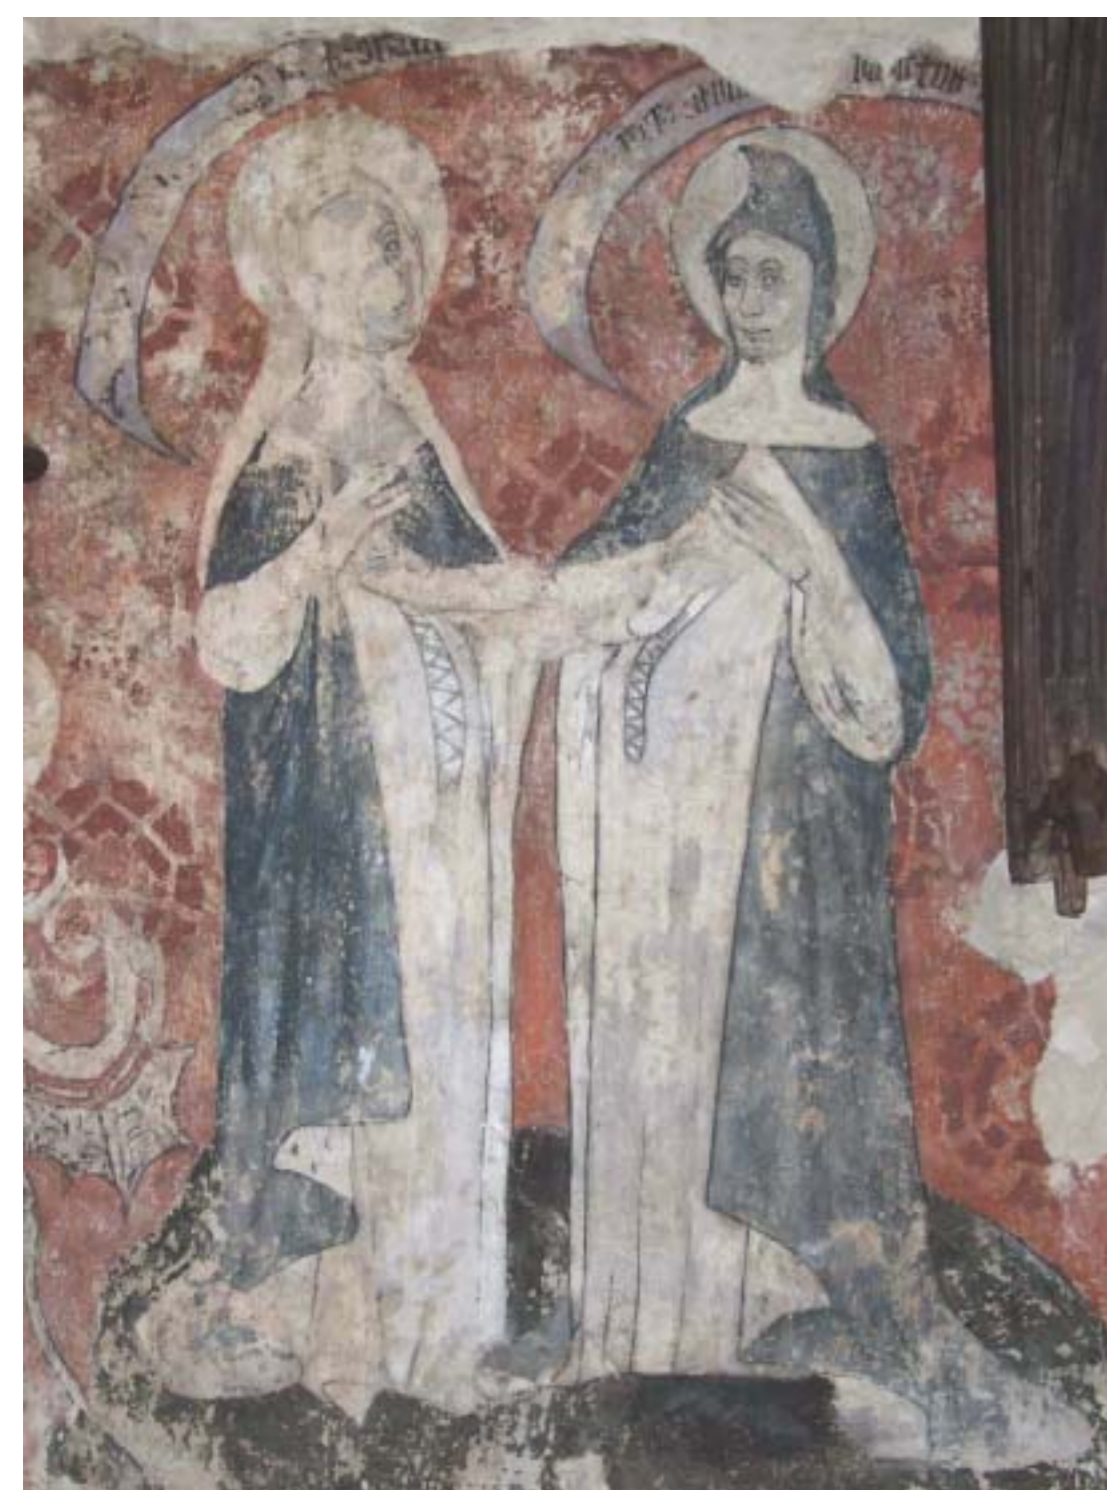
*The 15<sup>th</sup> Century Visitation on the south wall*

The Visitation is the best surviving scene from the Life of the Virgin cycle. Situated at the east end of the south arcade, the painting shows the haloed figures of the Virgin and St Elizabeth in blue robes, trimmed with ermine. To the west is the fragmentary scene of the Assumption of the Virgin, of which only the lower part of the painting remains. On the north wall is an extremely badly damaged Annunciation. The shields on the north and south arcade walls are contemporary with the scheme and contain both heraldic details and images from the Passion.

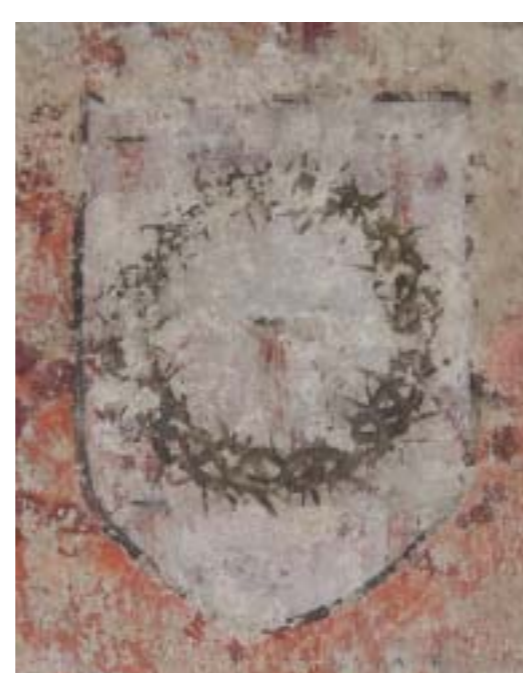
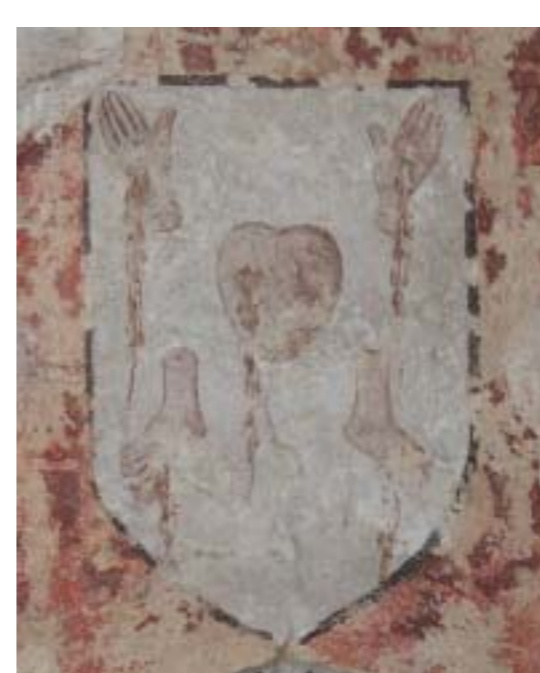
*15<sup>th</sup> Century shields with the wounds of the Passion, on the south wall of the nave*

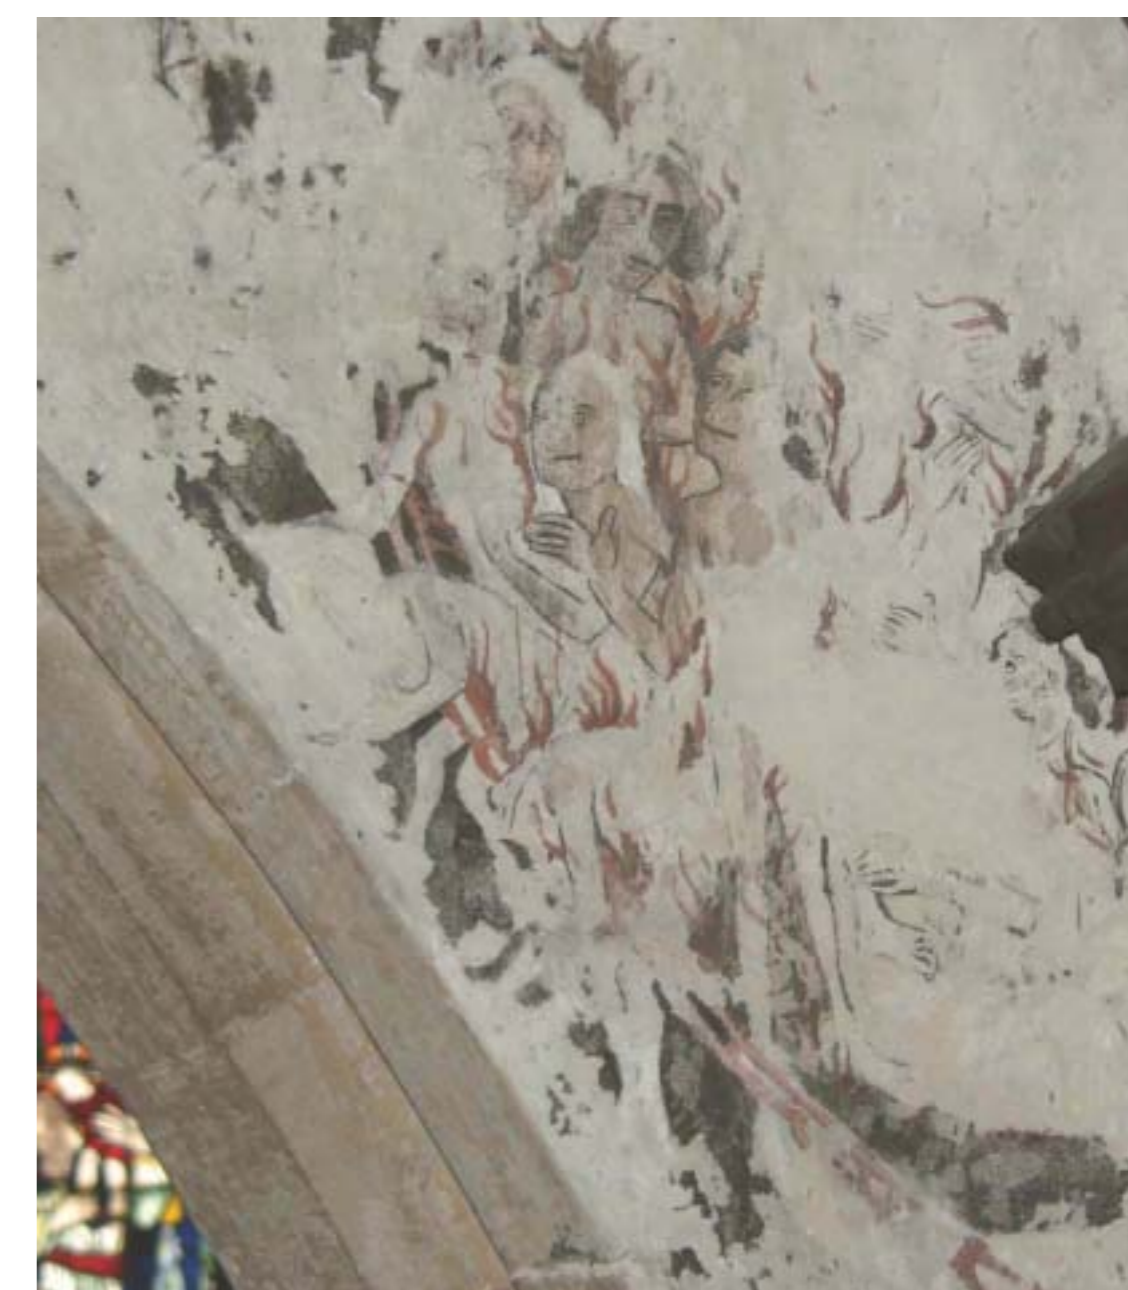
The most striking scheme of painting was carried out in the 15<sup>th</sup> century. Two fragments of the Doom survive on the north and south sides of the chancel arch. The one on the south side shows the Damned being tormented by demons and burned, while that on the north side shows the Blessed being welcomed by St Peter. The central section of the painting has been lost due to the insertion of a window, while the outer edges are obscured by the hammer beams of the roof. The Doom extends onto the south wall where, rather incongruously, two of the demons can be seen adjacent to the scene of the Visitation.

*Detail of the figures of the Damned in the mouth of Hell*

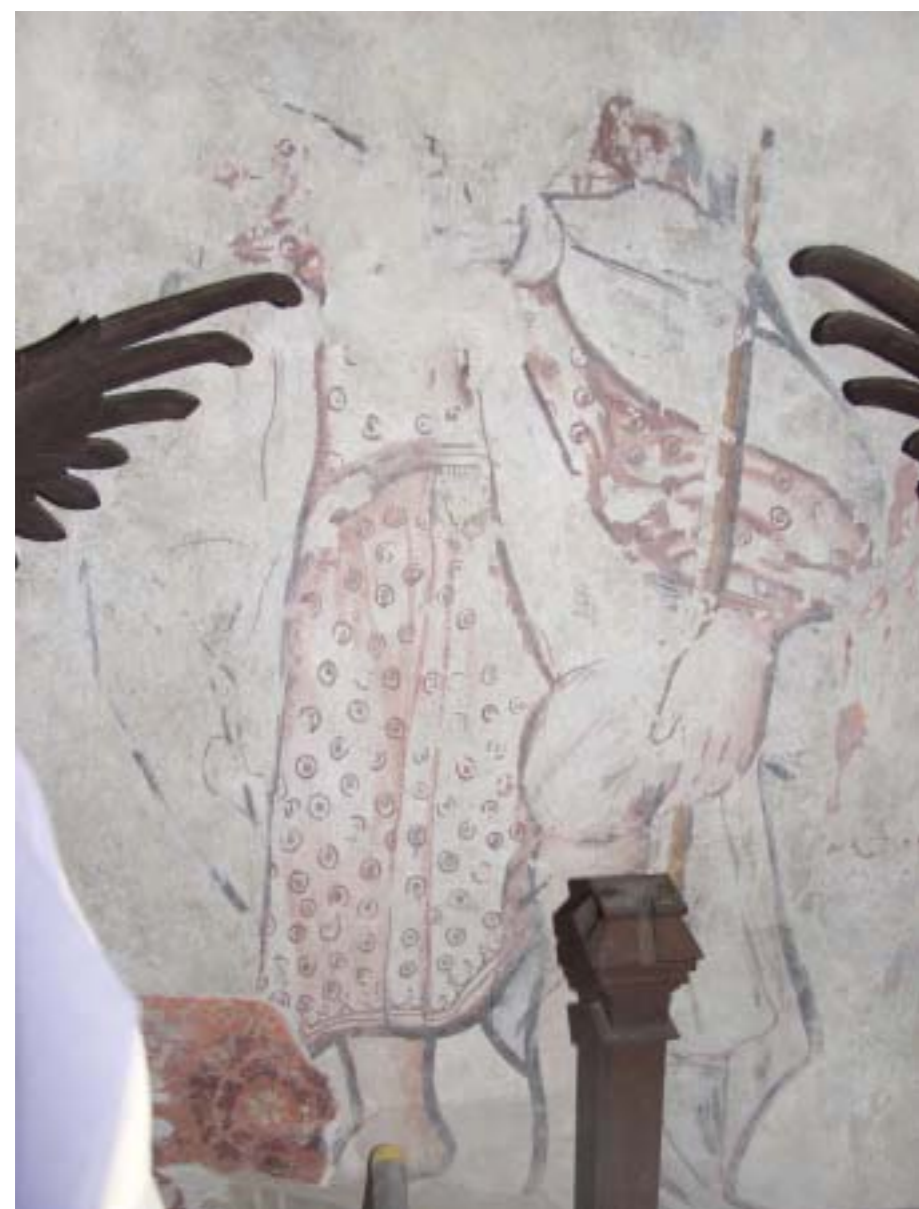
17<sup>th</sup> Century figure of St James the Great

On the north wall is the figure of Justice holding the scales and the sword. To the east is the fragmentary figure of Prudence holding a mirror to her face with her right hand and a snake in the left hand. Over the left side of the frame, surrounding St George, are the remains of the upheld arm of Temperance pouring water into a jug, while the bay to the right, which would presumably have held the figure of Fortitude, is entirely empty. Further to the east are the figures of another unidentified Apostle and then the figure of St Simon with his saw. Finally, at the east end of the wall, is the striking figure thought to be St James the Great, now partially hidden behind the organ pipes.

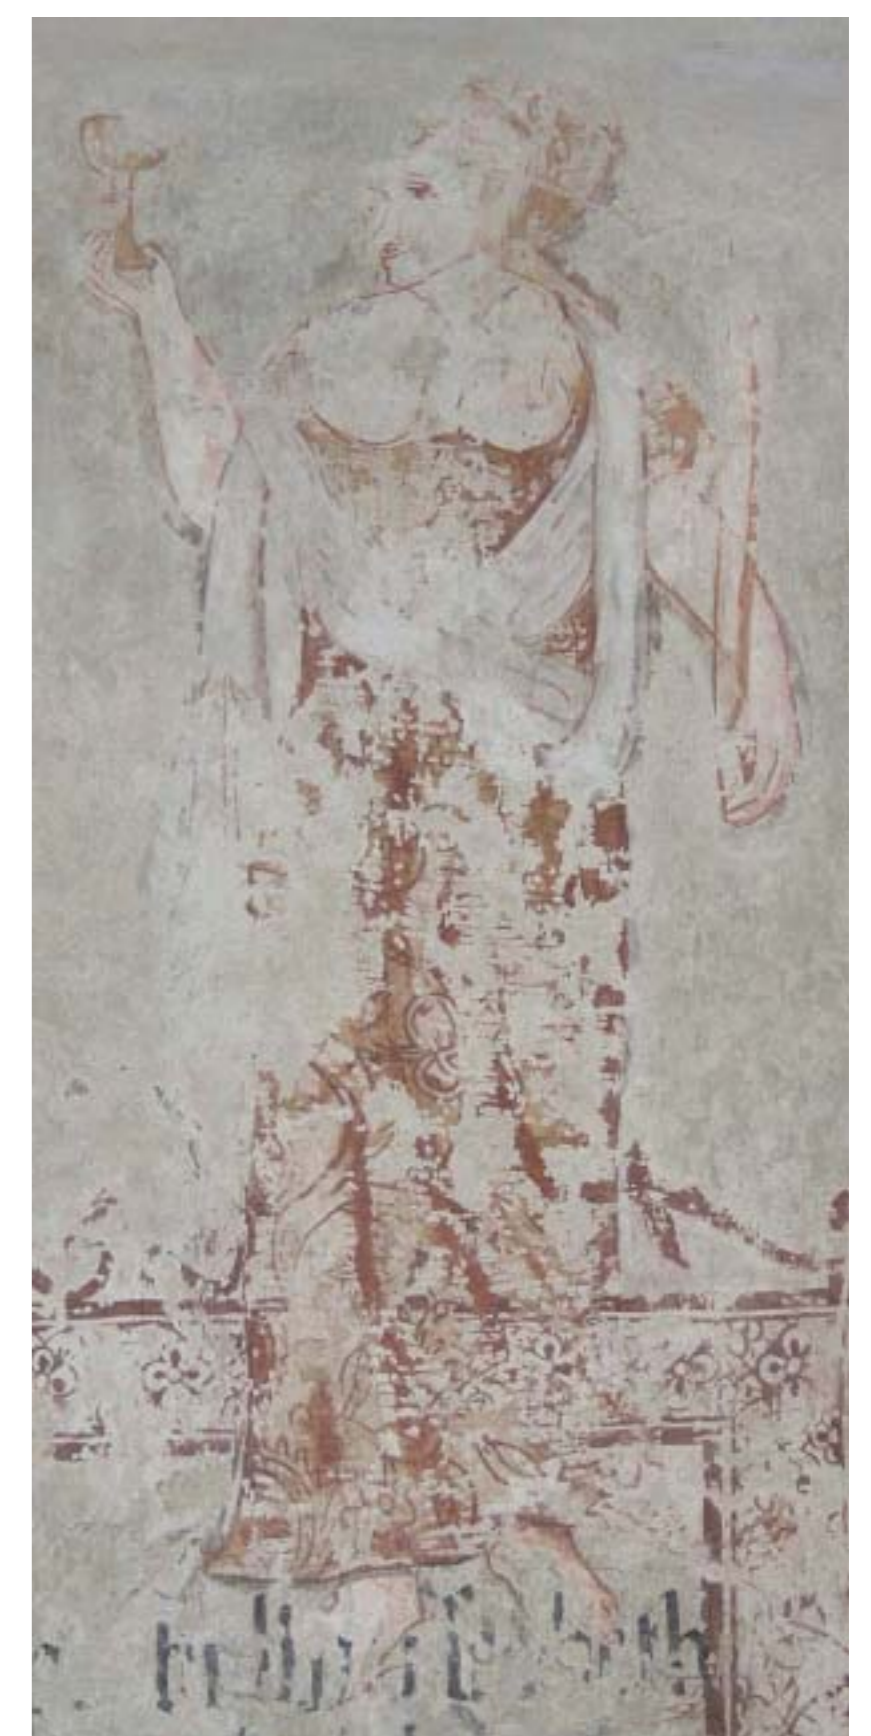
On the south wall of the nave, the first visible figure (from the east) is an unidentified bearded man dressed in 17<sup>th</sup> century costume. To the west is a figure holding a club, thought to be St James the Less. Proceeding further to the west are the three theological virtues starting with the voluptuous figure of Faith, holding a cup and a cross. Hope, with her robes picked out with blue/green decoration, is identified by the anchor, while to the west, Charity, although badly damaged, can be identified by the foot of the child that she holds.

17<sup>th</sup> Century figure of Faith

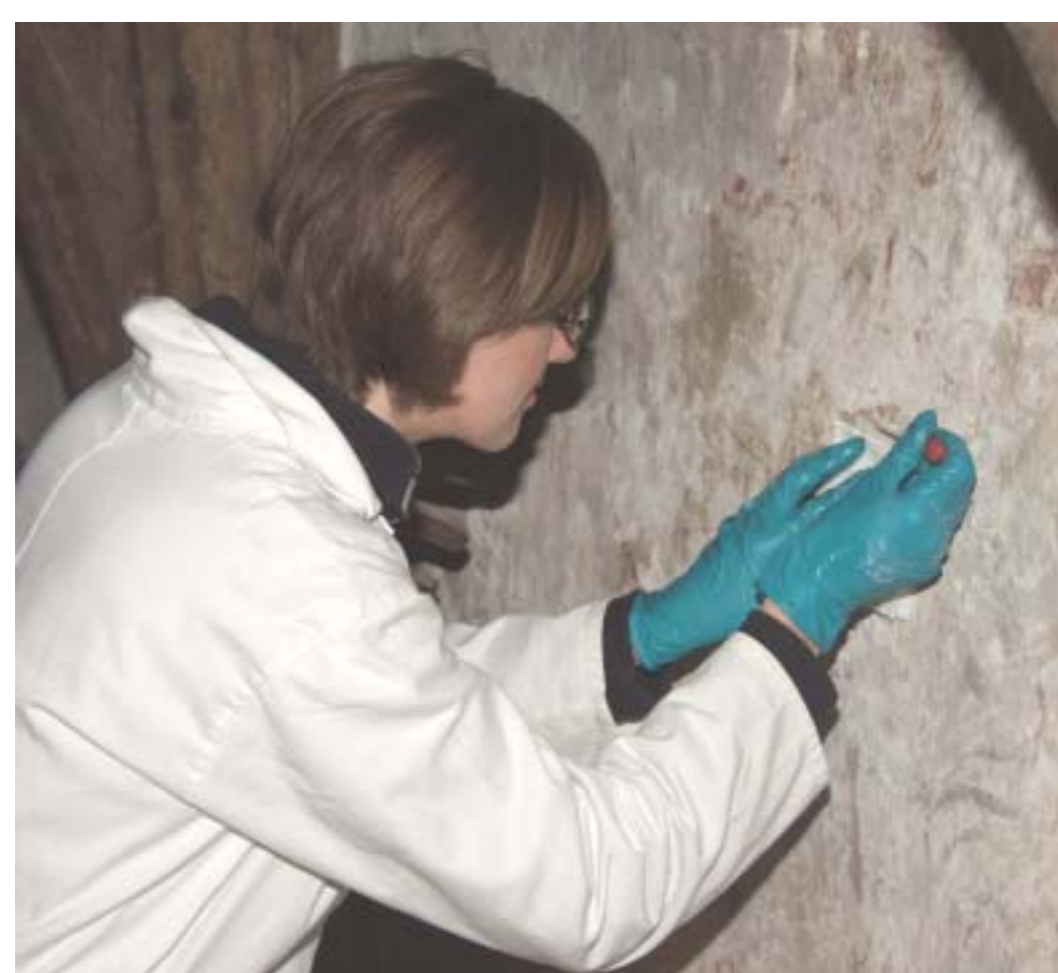
Conservator stabilising the paint layer

Since they were uncovered in 1895, areas of the paintings have been restored on a number of occasions. The most notable of these was in the 1930s when areas of the paintings were treated with a wax coating, which subsequently deteriorated and absorbed ambient dirt, making them dark and hard to read. Between 1979 and 1994 most areas of the later paintings at the east end of the nave were cleaned and restored. A survey of the paintings undertaken in 1995 showed that the areas of the wall paintings which had been treated in the recent past were in a relatively good condition. A number of small areas of flaking were noted but such damage was very limited. However, the later paintings, towards the west end, were far less stable and were likely to deteriorate further if left untreated.

In 2000 a programme of treatment was undertaken on the painting on the area surrounding St Simon, on the north wall. This allowed the treatment techniques for the remaining areas to be developed and refined. Following a fund raising programme by the parish, and the award of a grant from the Heritage Lottery Fund, a programme of conservation was undertaken on the remaining areas of wall paintings towards the west end of the nave. The aim of the work was to stabilise the wall paintings in order to prevent further deterioration and loss. In conjunction with this, the level of accumulated surface dirt was reduced, so that the paintings can be more clearly seen and the subject matter made more accessible to the viewer. The work was undertaken by a group of independent conservators co-ordinated by Tobit Curteis Associates, a Cambridge based practice specialising in the conservation of wall paintings. If you are interested in knowing more about the wall paintings or their conservation, please contact Tobit Curteis on 01223 501958 or Alan Fawcitt, wall painting secretary, on 01954 204024.

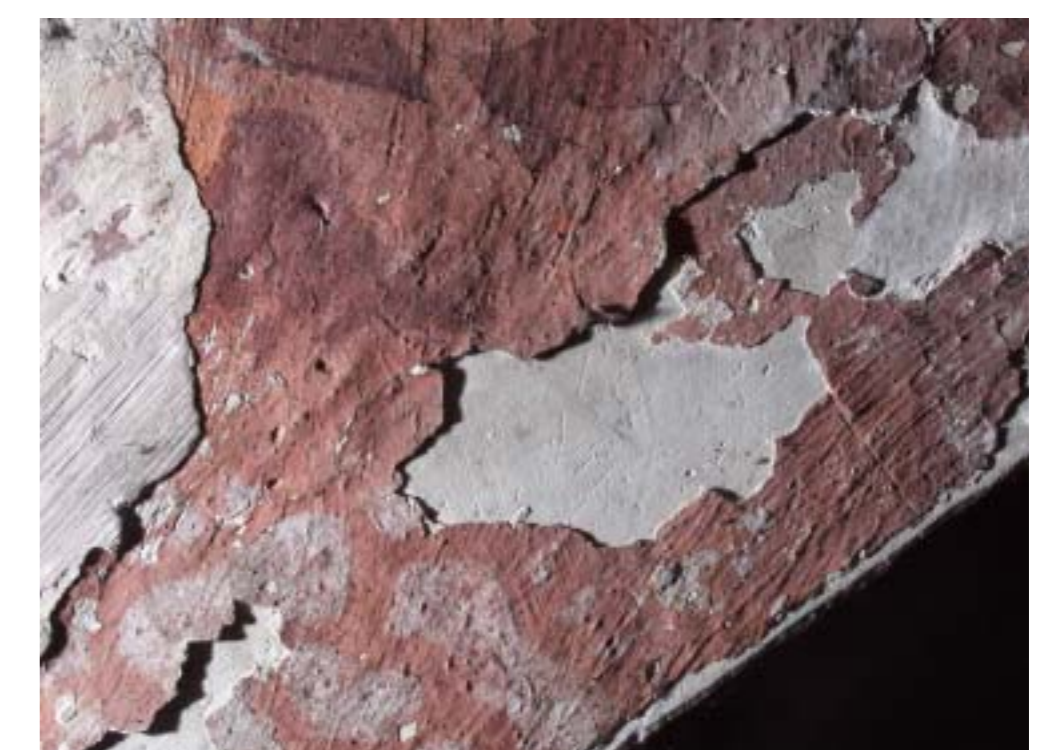
Delamination and flaking of the paint layer
