THE SURVEY AND IDENTIFICATION OF ENVIRONMENTAL DETERIORATION

TOBIT CURTEIS

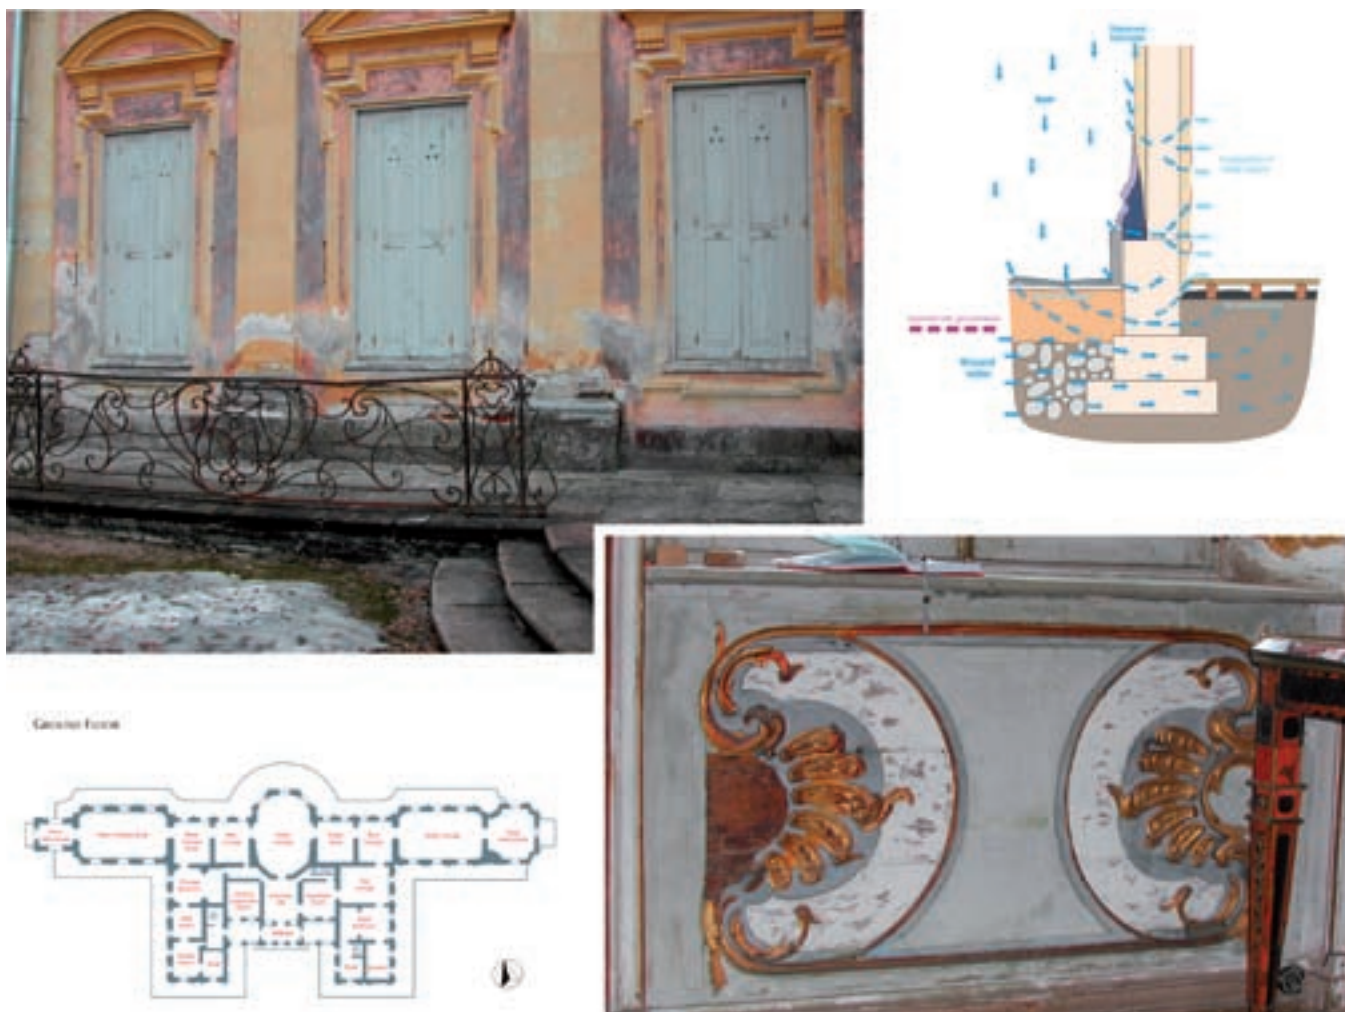
Figure 1: The Chinese Palace, Oranienbaum, Russia. Localised deterioration patterns characteristic of low level liquid water sources

Most of the basic investigation can be achieved with a careful study of the building envelope and the moisture transport routes. The design of any successful building envelope should enable rainwater deposited on the outer shell to be transported away to a safe location. If there is water damage on the internal surfaces, it suggests that either the design itself is faulty or that the system is damaged (Figure 1).

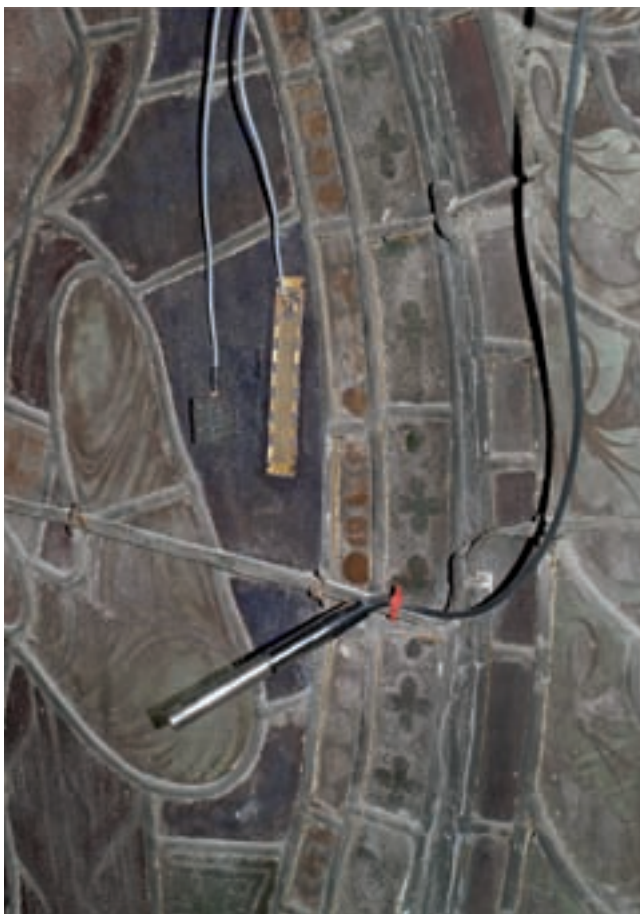
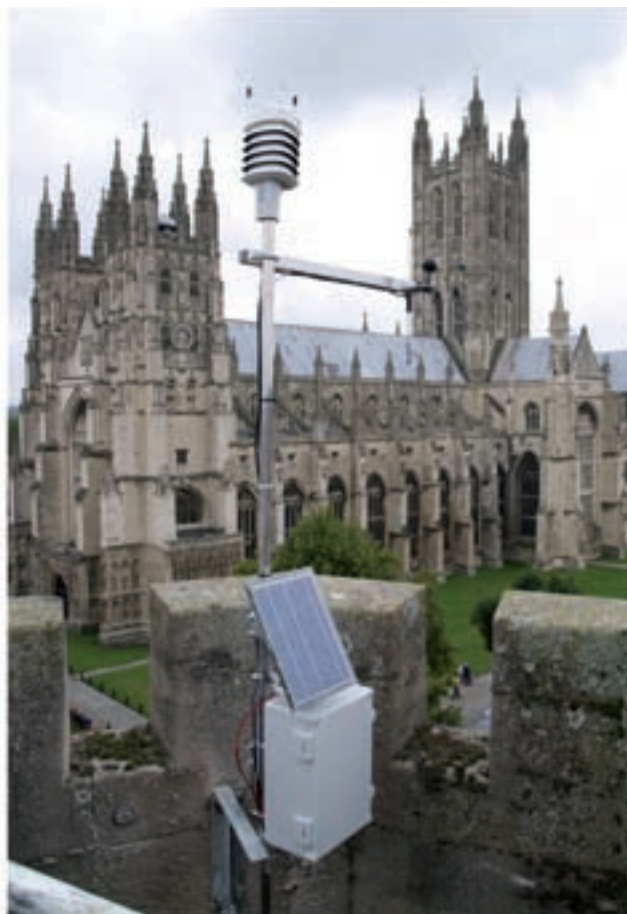
Figure 3: Monitoring the environmental conditions on medieval stained glass at Canterbury Cathedral (All images supplied by Tobit Curteis Associates)

These issues can be examined by a carefully designed programme of environmental monitoring. Monitoring, as opposed to measuring, involves collecting a large set of data over a prolonged period so that the pattern of microclimatic change can be observed. If the heating is turned on or a window is opened, for example, how does this affect the microclimate and how in turn does this affect the deteriorogens (Figure 3)?
